New gasket for kit TK5194

Issues with Opel 1.6 TCDi engines

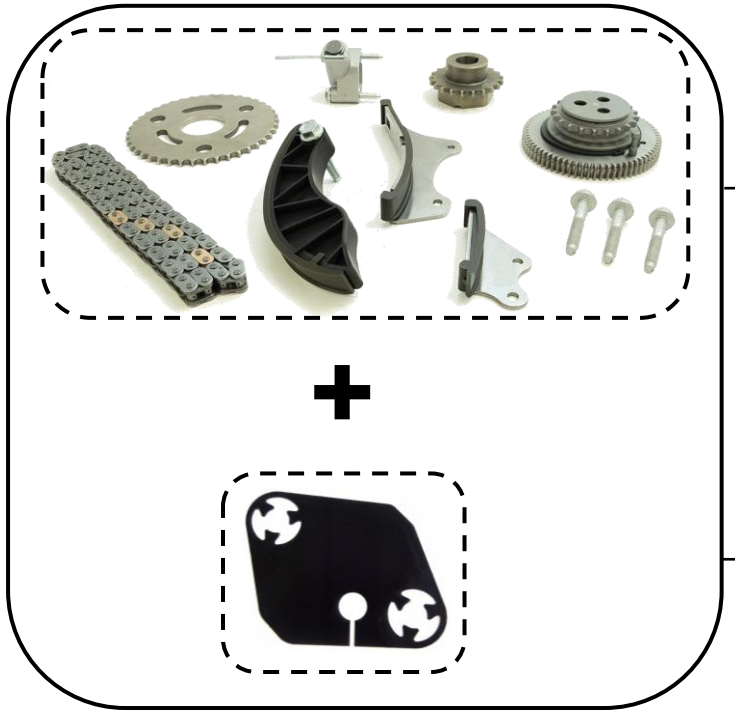
Gasket
OE #: 55515025

Rattling noise, especially when **cold** or during start-up, mainly caused by **loss of timing chain tension**.

- **Inefficient hydraulic timing chain tensioner**

The tensioner loses pressure due to oil leaking back into the oil sump.

The gasket supplied with kit KT5194 is installed between the timing chain tensioner and the engine block to ensure proper sealing and prevent oil leaks. It ensures that oil flow and pressure within the timing system are correctly maintained, preventing oil from escaping and avoiding possible hydraulic tensioner inefficiency.

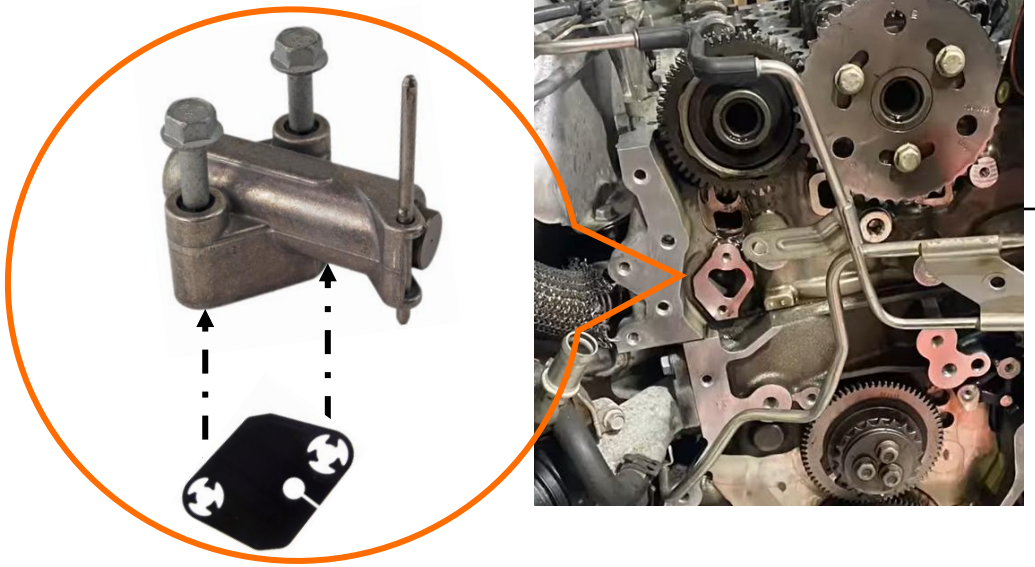
- Repeated starts with the chain not properly tensioned accelerate wear.
- Over time, the noise becomes more frequent and more noticeable.
